Manhole Inspection Summary

Manhole # S41AA_034MH

Insp Date: **8/7/08 9:43 AM**

Location Address: **800 n caroline st**

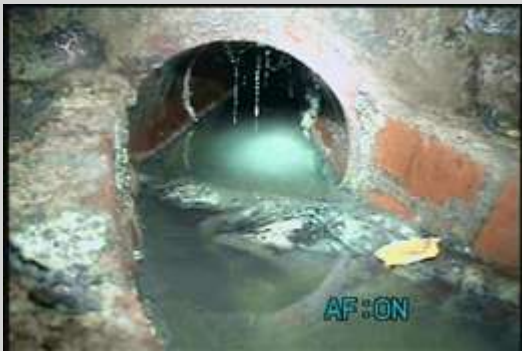
9 O'Clock Inflow

8 in. Circular Gravity Sewer
Pipe In @ 9 O'Clock

Pipe Material: **Clay** ☐ Pipe Lined

Infiltration: **None**
